**A. I. NEDOBITKOV**, Candidate of Technical Sciences, Associate Professor,  
Department of Informatics and Mathematics, Kazakh Humanitarian Law  
Innovative University (Astana St., 48, Ust-Kamenogorsk, 070014, Kazakhstan;  
e-mail: a.nedobitkov@mail.ru)

## SPECIFIC FEATURES OF SHORT CIRCUIT IN AUTOMOBILE ELECTRICAL SYSTEM

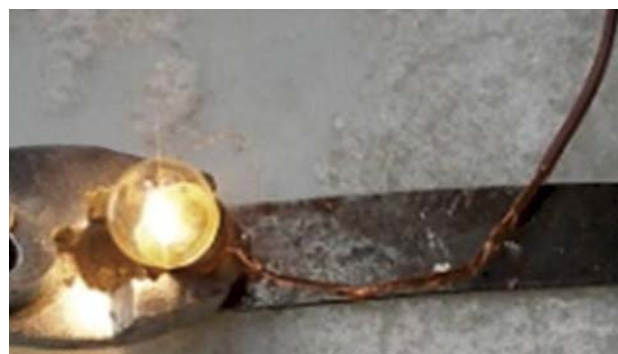
**Fig. 3.** Air gap that is equal to the thickness of the wire insulation and prevents the occurrence of a short circuit in the automobile electrical system

It should also be noted that the air gap between the bare copper conductor and the steel band that is equal to the thickness of the conductor insulation (in this case its thickness is about 0.4 mm), prevents short-circuit, in spite of the fact that according to the scheme in Fig. 1a, the voltage is maintained in the circuit by means of 51AH/280A battery and the filament of the electric bulb emits light (Fig. 3).
